RE: NPDES/MS4 - Year 1 Progress Report for the Universities at Shady Grove

**National Pollutant Discharge Elimination System (NPDES)
Small Municipal Separate Storm Sewer Systems (MS4) General Permit**

APPENDIX C: RESTORATION WORKPLAN FOR THE FAILING BMP'S:
BIOSWALES AT PARKING LOT 1

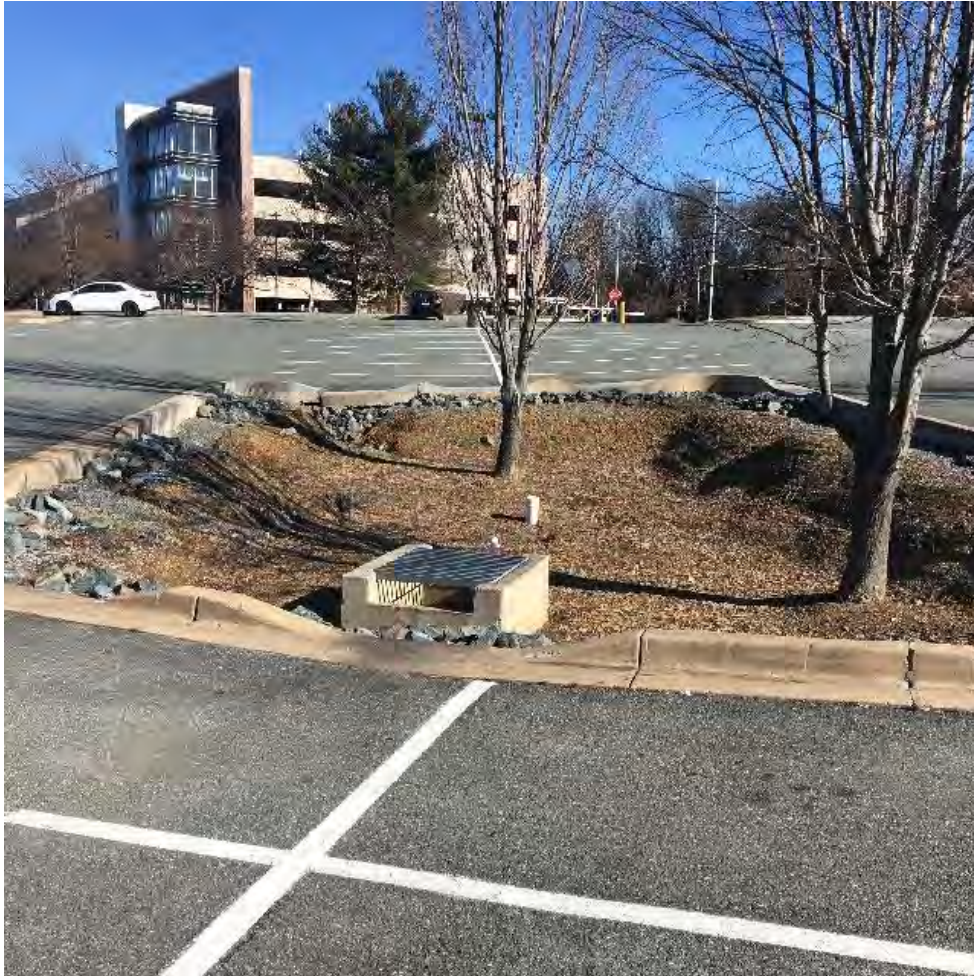
Overall Photo

Date of Inspection:	01/15/2019 2:39 PM	Inspector Initials	SAL,JK,CAB
BMP ID	USG19BMP00019	Inspection Firm	MES
BMP Type:	Bioretention	Underground BMP?	No
Rating:	C - Failing, needs major maintenance	Overall Inspection Comment	Major erosion at inflows - undermining of western curb, Vegetation Removed from BMP 2013. Repair erosion, replace bioretention plants, remove tree, and remediate BMP to current MDE standards. +/-12" ponding depth in BMP

- **BMP Access** - Good
- **Debris & Sediment** - Good
- **Vegetation** - Poor
 - Non-Woody Vegetation Removed 2013, Maple trees show evidence of distressed health
- **BMP Contamination** - Good
- **Inflow Condition** - Poor
 - Undermining of curbing at west curb opening. Erosion at Gravel Curtain Drain
- **Forebay** - Not Rated
 - Not Part of Design
- **Conveyance Stability** - Fair
- **Downstream Condition** - Not Rated
 - Site outfalls to existing stormwater network

Overall Rating - C - Failing, needs major maintenance

The bioretention is considered failing and requires major maintenance to restore to functioning condition. Maintenance recommendations to restore the bioretention to a functioning condition include: Regrade and restore bioretention to design criteria. Replanting of MDE approved bio-wetland plants. MES recommends removing the maple tree and replace with other MDE approved bioretention plants. Restore parking lot curb along perimeter/inflows of the bioretention facility. Perform additional maintenance as directed by project engineer to restore structural integrity of the surrounding parking lot.

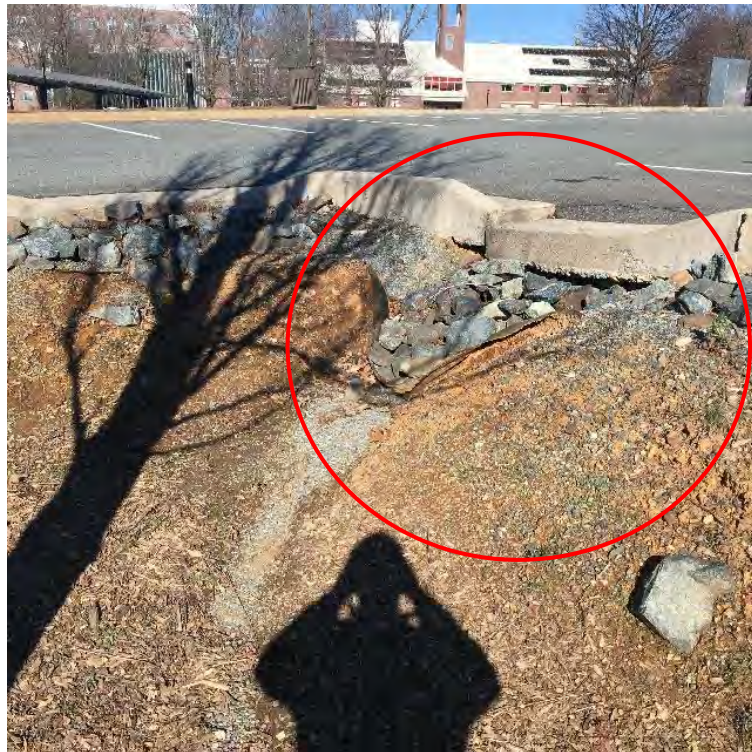
Inflow - Curb Cut, Facing West, Curb Damaged and Undermined

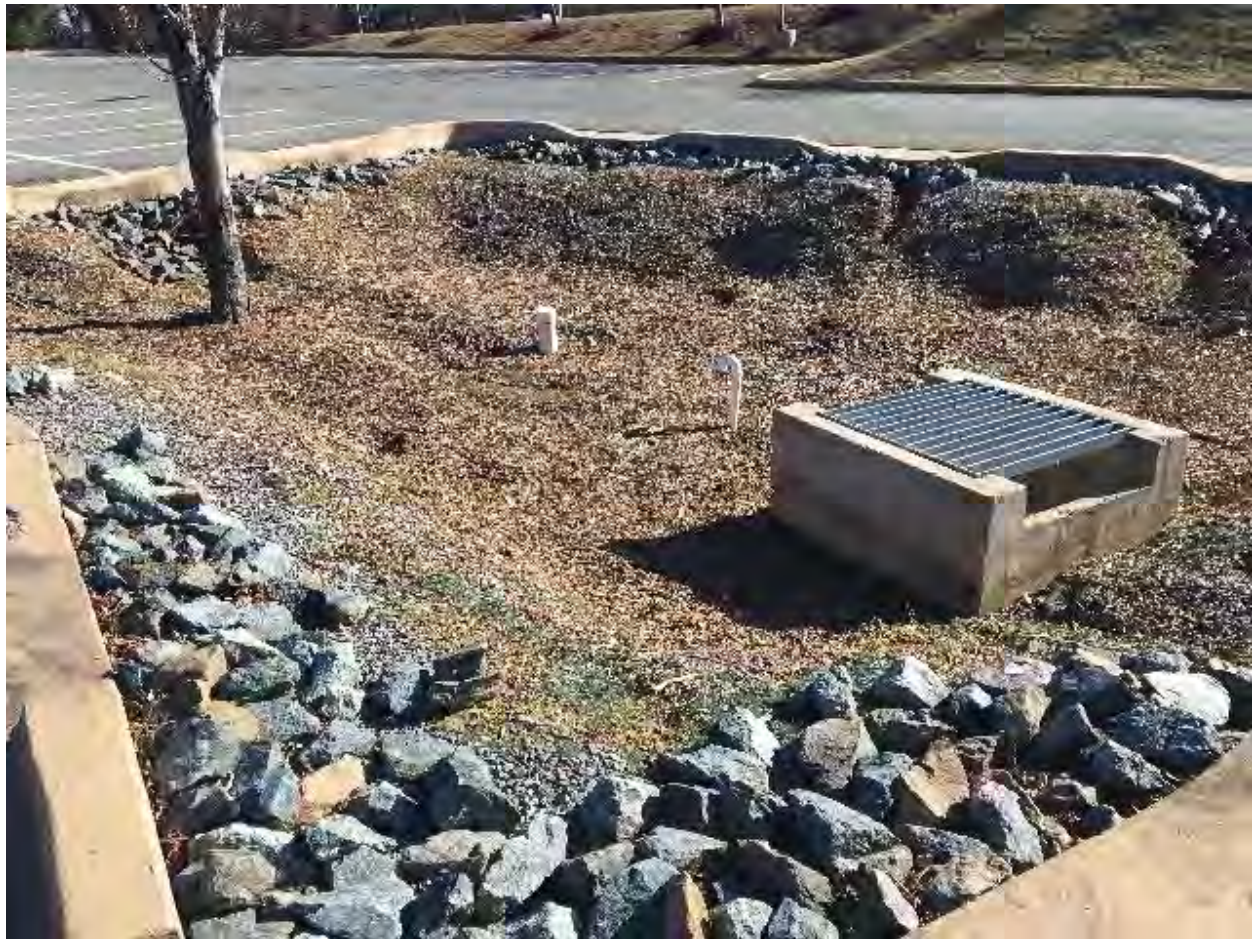
Overall Photo

Date of Inspection:	01/11/2019 2:09 PM	Inspector Initials	SAL,JK,CAB
BMP ID	USG19BMP00020	Inspection Firm	MES
BMP Type:	Bioretention	Underground BMP?	No
Rating:	C - Failing, needs major maintenance	Overall Inspection Comment	Erosion at curb cut inflow and gravel curtain drain, excessive ponding potential at overflow device, vegetation removed 2013. Repair erosion, replace bioretention plants, remove tree, and remediate BMP to current MDE standards. +/-12" ponding depth in BMP

- **BMP Access** - Good
- **Debris & Sediment** - Good
- **Vegetation** - Poor
 - Non-Woody Vegetation Removed 2013, Maple trees show evidence of distressed health
- **BMP Contamination** - Good
- **Inflow Condition** - Poor
 - Erosion at inflows of curb cuts surrounding the BMP. Evidence of parking lot integrity being undermined. Erosion at gravel curtain drain
- **Forebay** - Not Rated
 - Not Part of Design
- **Conveyance Stability** - Poor
 - Erosive channel along embankment
- **Downstream Condition** - Not Rated
 - Site outfalls to existing stormwater network

Overall Rating - C - Failing, needs major maintenance

The bioretention is considered failing and requires major maintenance to restore to functioning condition. Maintenance recommendations to restore the bioretention to a functioning condition include: Regrade and restore bioretention to design criteria. Replanting of MDE approved bio-wetland plants. MES recommends removing the maple tree and replace with other MDE approved bioretention plants. Restore parking lot curb along perimeter/inflows of the bioretention facility. Perform additional maintenance as directed by project engineer to restore structural integrity of the surrounding parking lot.

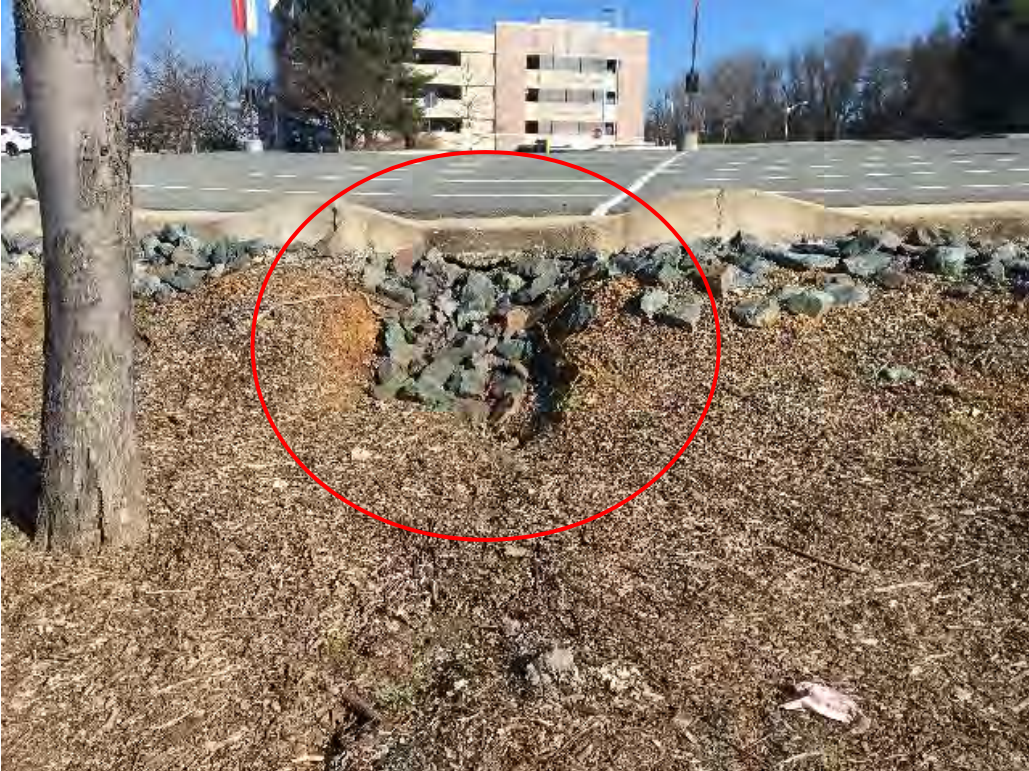
Erosion at Inflow B - Curb Cut - Facing West

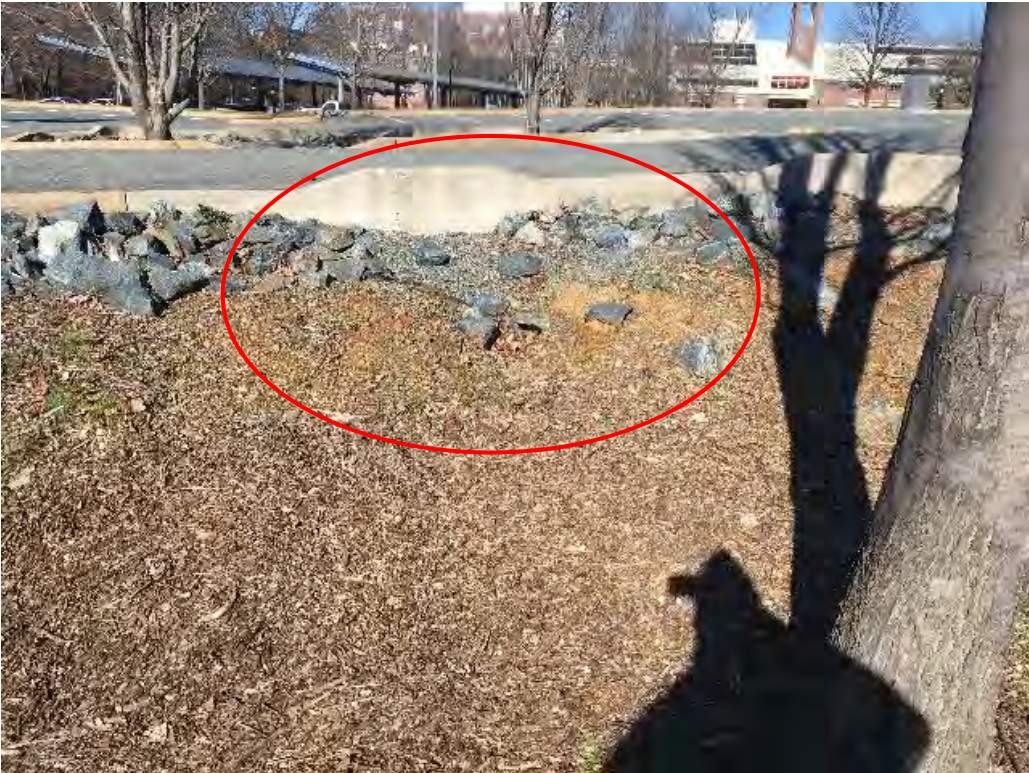
Erosion at Gravel Curtain - Facing North

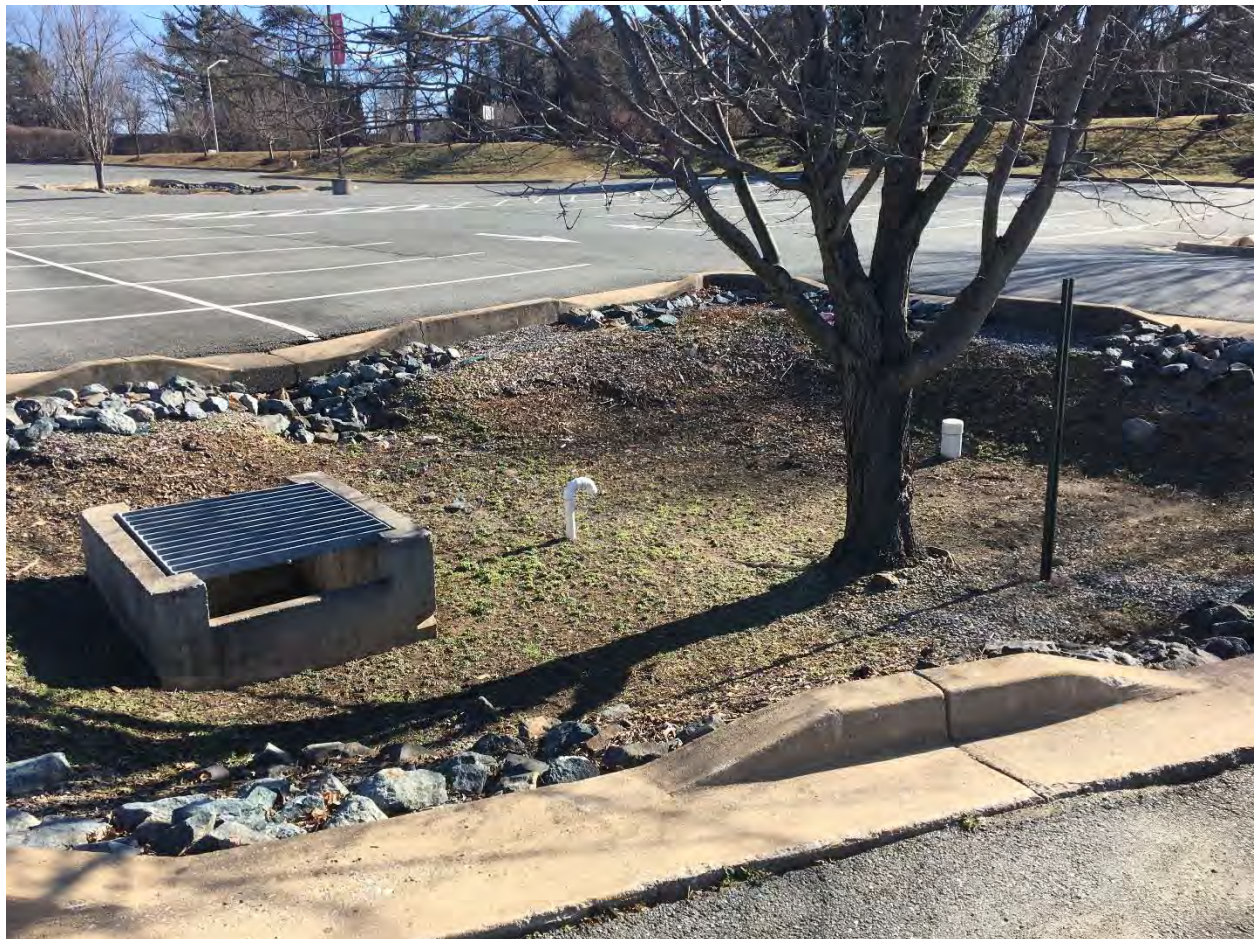
Overall Photo

Date of Inspection:	01/11/2019 12:23 PM	Inspector Initials	SAL,JK,CAB
BMP ID	USG19BMP00021	Inspection Firm	MES
BMP Type:	Bioretention	Underground BMP?	No
Rating:	C - Failing, needs major maintenance	Overall Inspection Comment	Erosion at curb cut inflow and gravel curtain drain, excessive ponding potential at overflow device, vegetation removed 2013. Repair erosion, replace bioretention plants, remove tree, and remediate BMP to current MDE standards. +/-12" ponding depth in BMP

- **BMP Access** - Good
- **Debris & Sediment** - Fair
- **Vegetation** - Poor
 - BMP Vegetation Removed 2013, Maple trees show evidence of distressed health
- **BMP Contamination** - Good
- **Inflow Condition** - Poor
 - Erosion at inflows of curb cuts surrounding the BMP. Evidence of parking lot integrity being undermined. Erosion at gravel curtain drain
- **Forebay** - Poor
 - Erosion of Curtain Drain Pretreatment
- **Conveyance Stability** - Fair
- **Downstream Condition** - Not Rated
 - Site outfalls to existing stormwater network

Overall Rating - C - Failing, needs major maintenance

The bioretention is considered failing and requires major maintenance to restore to functioning conditions. Maintenance recommendations to restore the bioretention to functioning conditions include: Removal of debris, unplanned and woody vegetation within facility. Replanting of MDE approved bioorientation plants according to design. Repair of eroded areas at the inflows and gravel curtain drain. Investigation of underdrain for potential clogging and removal of sediment if necessary. Removal of any sediment build up on surface of facility or addition of mulch to meet MDE ponding depth requirement.

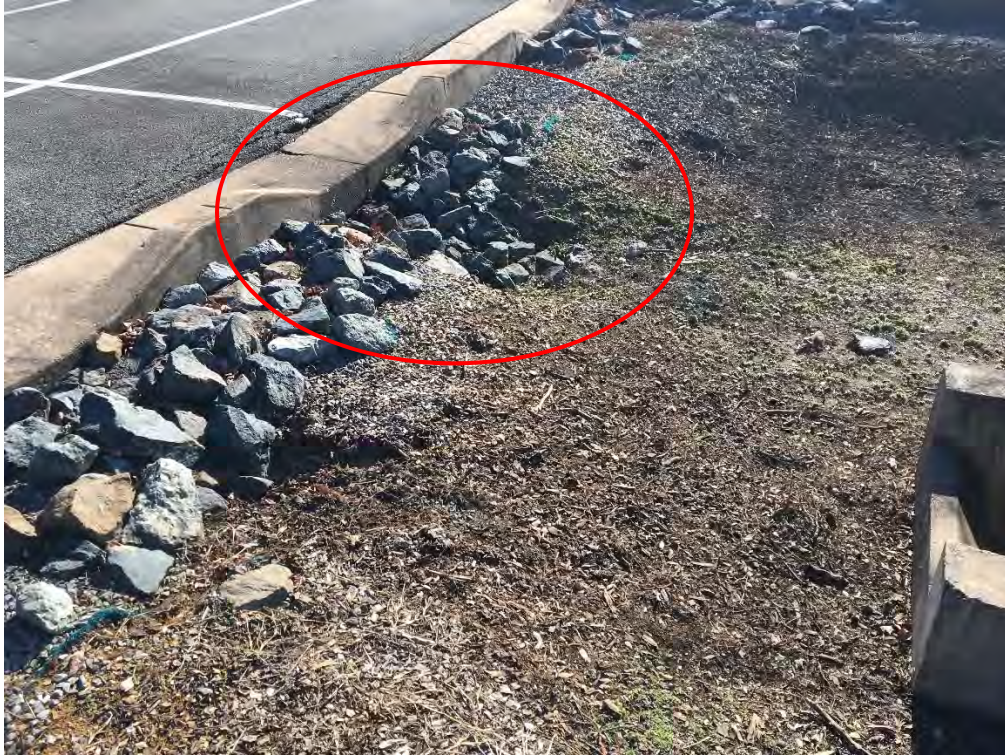
Erosion at inflow, water flows under curbing

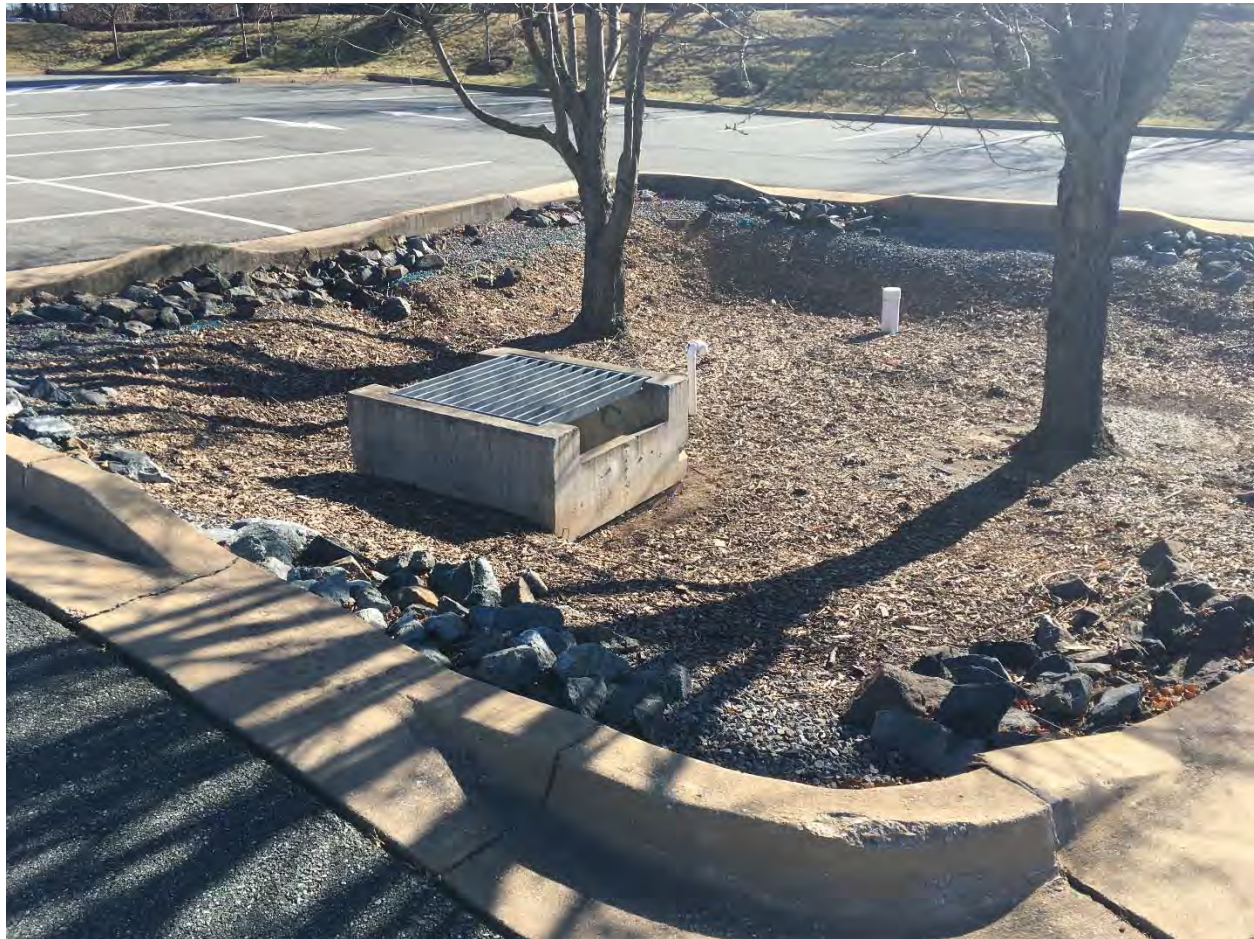
Overall Photo

Date of Inspection:	01/11/2019 1:48 PM	Inspector Initials	SAL,JK,CAB
BMP ID	USG19BMP00022	Inspection Firm	MES
BMP Type:	Bioretention	Underground BMP?	No
Rating:	C - Failing, needs major maintenance	Overall Inspection Comment	Erosion at curb cut inflow and gravel curtain drain, excessive ponding potential at overflow device, vegetation removed 2013. Repair erosion, replace bioretention plants, remove tree, and remediate BMP to current MDE standards. +/-12" ponding depth in BMP

- **BMP Access** - Good
- **Debris & Sediment** - Good
- **Vegetation** - Poor
 - Non-Woody Vegetation Removed 2013, Maple trees show evidence of distressed health
- **BMP Contamination** - Good
- **Inflow Condition** - Poor
 - Erosion at inflows of curb cuts surrounding the BMP. Evidence of parking lot integrity being undermined. Erosion at gravel curtain drain
- **Forebay** - Not Rated
 - Gravel Curtain Drain Eroded and Riprap added
- **Conveyance Stability** - Fair
- **Downstream Condition** - Not Rated
 - Site outfalls to existing stormwater network

Overall Rating - C - Failing, needs major maintenance

The bioretention is considered failing and requires major maintenance to restore to functioning condition. Maintenance recommendations to restore the bioretention to a functioning condition include: Regrade and restore bioretention to design criteria. Replanting of MDE approved bio-wetland plants. MES recommends removing the maple tree and replace with other MDE approved bioretention plants. Restore parking lot curb along perimeter/inflows of the bioretention facility. Perform additional maintenance as directed by project engineer to restore structural integrity of the surrounding parking lot.

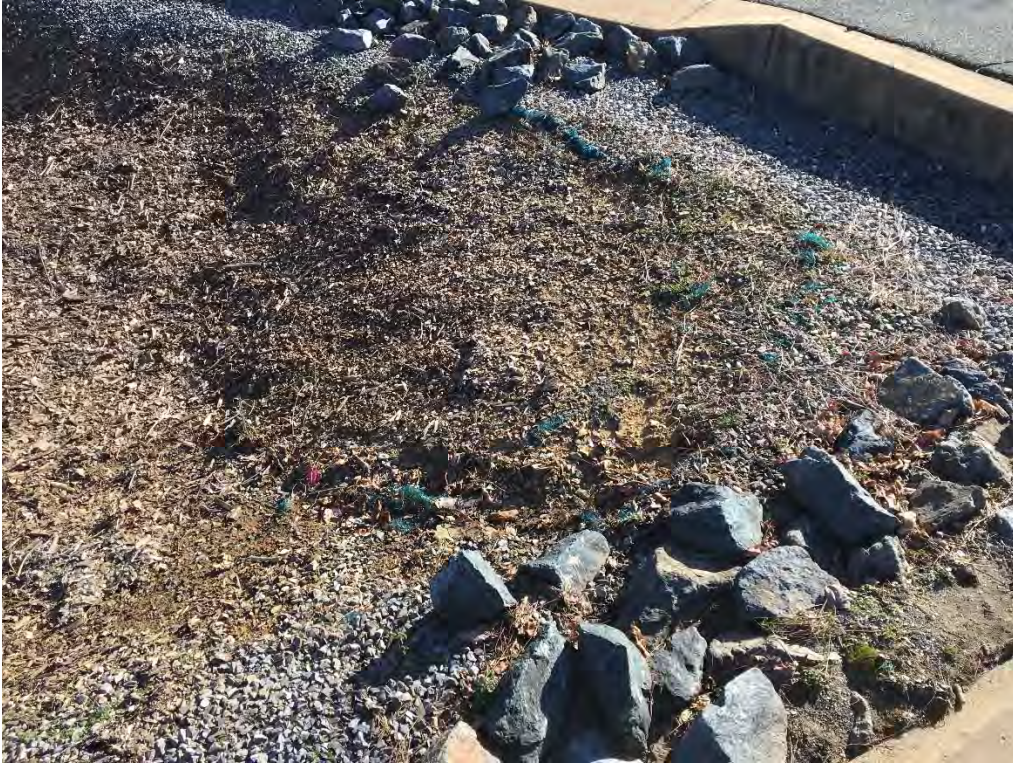
Sediment within Curtain Drain, Erosion at Curb Cut

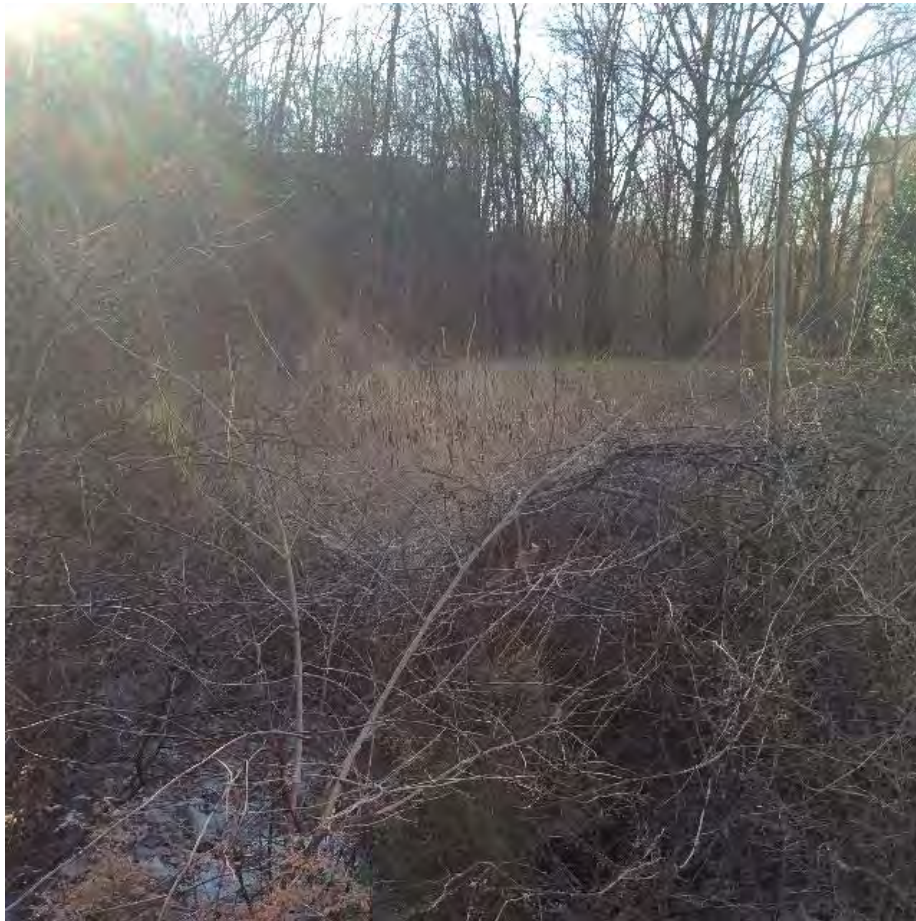
Overall Photo

Date of Inspection:	01/15/2019 8:30 AM	Inspector Initials	SAL,JK,CAB
BMP ID	USG19BMP00002	Inspection Firm	MES
BMP Type:	Sand Filter	Underground BMP?	No
Rating:	C - Failing, needs major maintenance	Overall Inspection Comment	Excessive unwanted vegetation, embankment blown out at wier, ponding, BMP designed with excess sand, tree growth on embankment. Remove vegetation, remediate to MDE criteria, restore embankment to design criteria

- **BMP Access** - Good
- **Debris & Sediment** - Fair
- **Vegetation** - Poor
 - Overgrown Vegetation, invasive species present, cattail growth reducing treatment capacity
- **BMP Contamination** - Good
- **Inflow Condition** - Fair
- **Forebay** - Not Rated
 - Not Part of Design
- **Conveyance Stability** - Fair
- **Downstream Condition** - Good

Overall Rating - C - Failing, needs major maintenance

The sand filter is considered failing and requires major maintenance to restore to functioning condition. Maintenance recommendations to restore the sand filter to functioning condition include: Removal of debris, unplanned and woody vegetation within a 10' buffer around the facility. Daylight 8" PVC inflow and repair and reset riprap at inflow. Removal of sediment and vegetation within the facility and dispose at an approved location. Excavation and reinstallation of the sand filter. Regrade the embankment to original design. If ENAKMAT 4010 device is compromised, reconstruct as designed. Removal of debris, unplanned and woody vegetation within a 15' from the downstream and upstream toe of the embankment and control structure. Recommend installing an underdrain and forebay to bring to approved MDE design standards. Facility may not be feasible in current location due to low grade and adjacent wetland. Site is located on type C soils.
