The Universities at Shady Grove
National Pollutant Discharge Elimination System
MS4 Phase II Annual Report - Year 3 (FY 2021)
General Discharge Permit #13-SF-5501

October 25, 2021

USG Campus Site Map

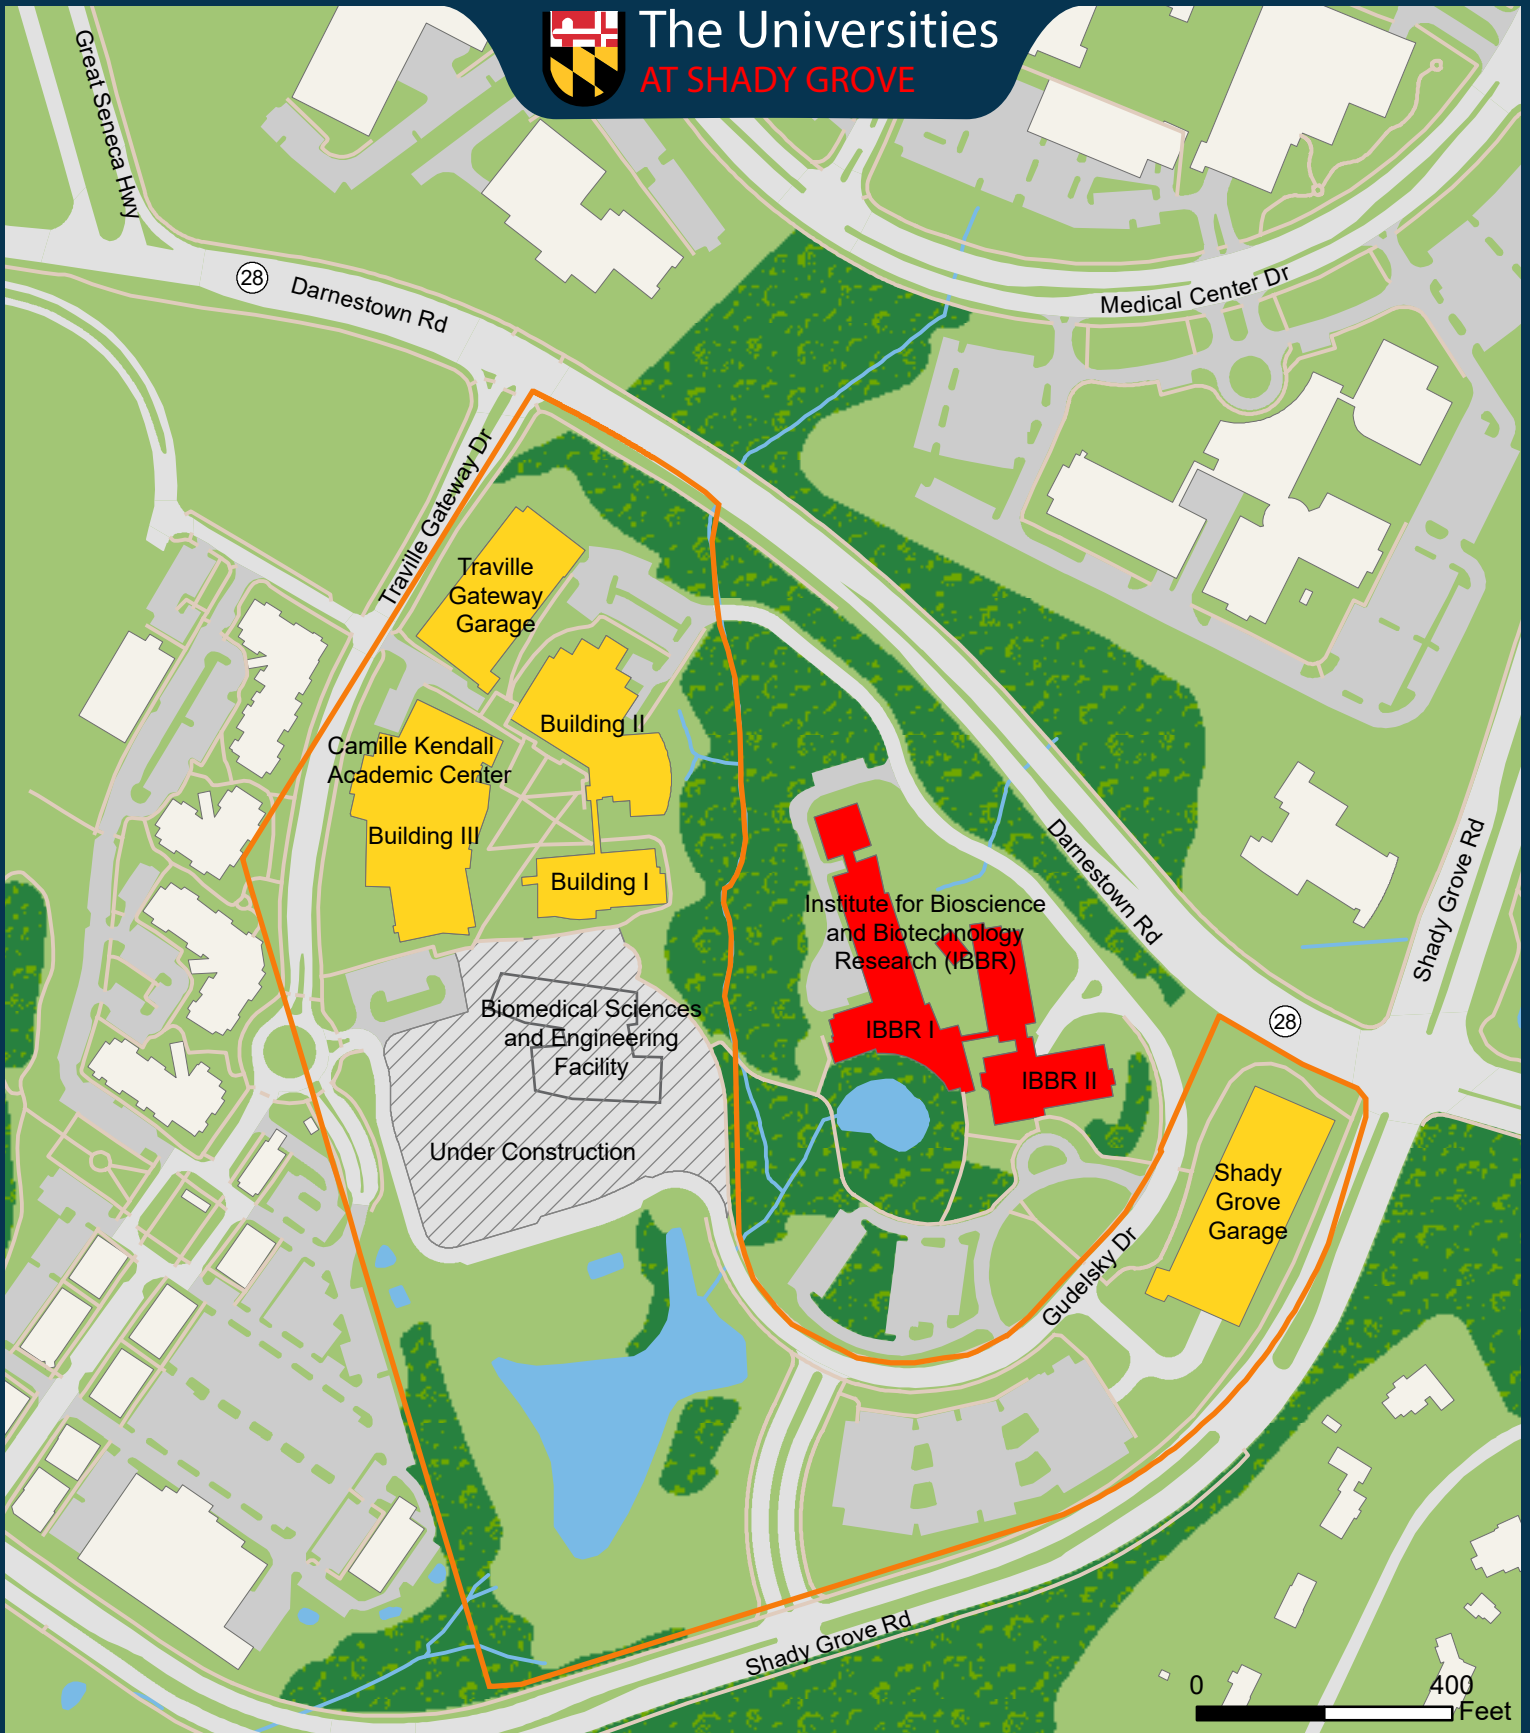
It should be noted that USG (a USM institute) and IBBR (a University of Maryland at College Park institute) share the campus jointly; however, there are separate NOI's for USG and IBBR. This Year 3 progress report only covers the 34 acres that are managed by USG, as shown on the Site Map.

— Management Boundary 34 Acres

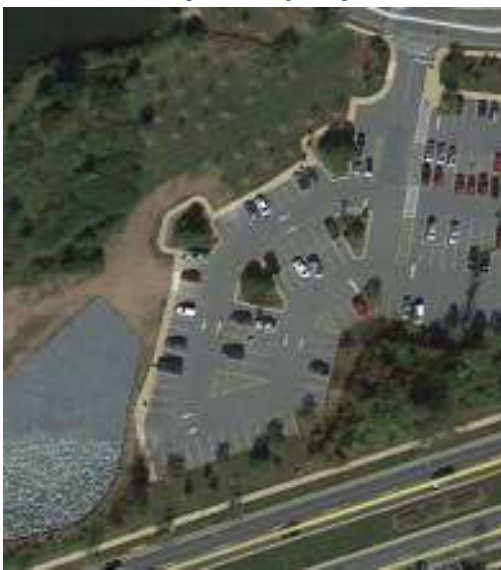
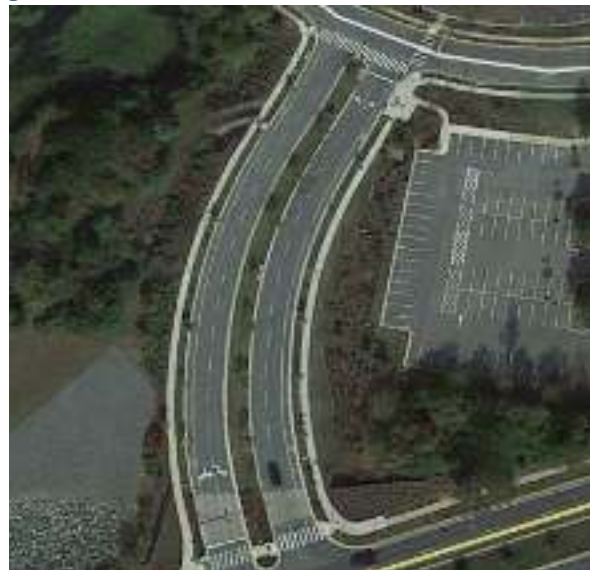
Figure 1. New Campus Entry Impervious Area Change

MES used aerial imagery to estimate the change in impervious for New Campus Entry. It was determined there was no increase in impervious, as shown in Figure 1, therefore the project was not subject to new development requirements.

Existing Impervious = 0.74 acres

Proposed impervious = 0.72 acres

However, this project did not qualify for restoration credit because the existing impervious was fully treated by a combination of micro-biorententions, since removed as part of redevelopment, and Gudelsky Pond. Therefore, treatment of the redeveloped impervious provided by the newly constructed micro-biorententions and Gudelsky was credited toward treatment of the baseline.

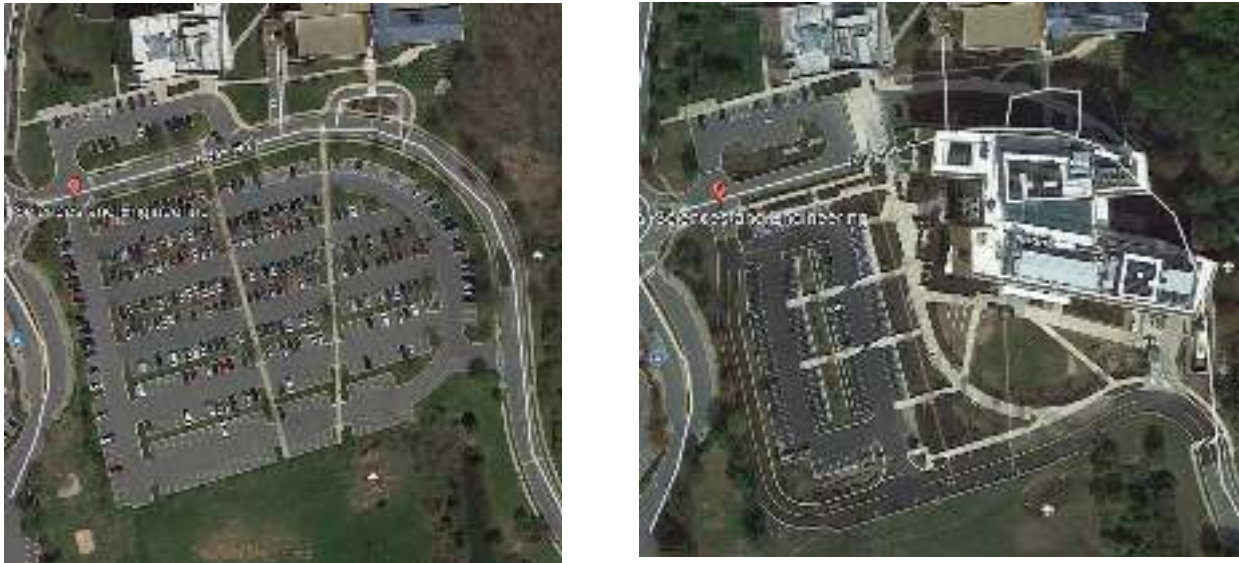
Figure 2. BSE Impervious Area Change

The design plans provided for the BSE redevelopment project indicated the project resulted in a net decrease in impervious, demonstrated by Figure 2.

Existing Impervious = 4.1 acres Proposed Impervious = 3.65 acres

Additionally, the plans indicated an existing sand filter, removed during the BSE construction, provided treatment for 1.2 acres of impervious. Gudelsky Pond also provided treatment of the existing impervious surface, with a computed credit of 1.23 acres. Since the existing impervious area was not fully treated, this project was eligible for restoration credit.

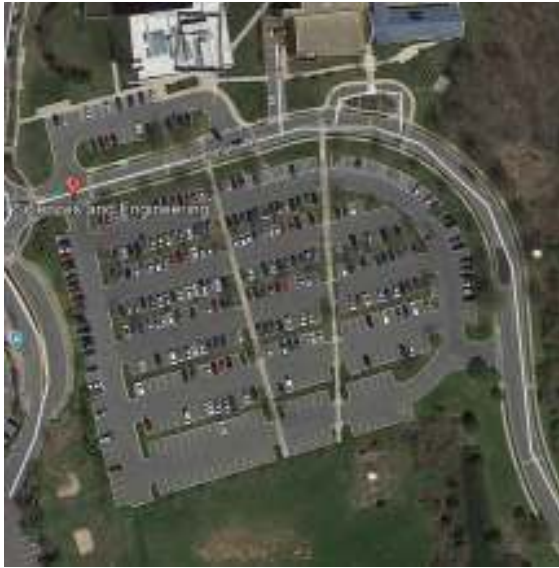
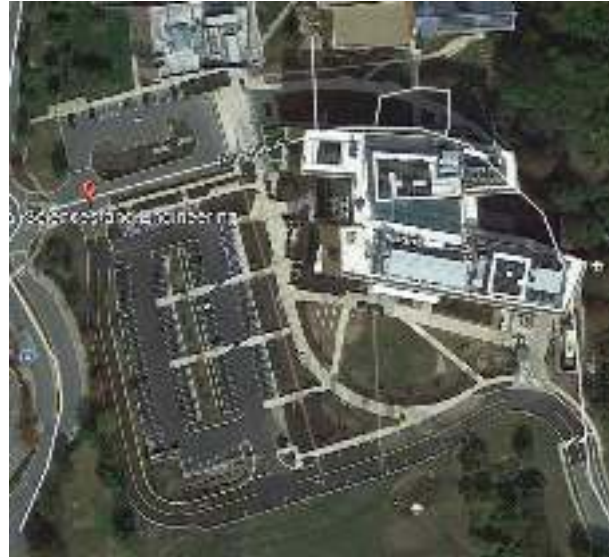
Appendix A: Redevelopment Analysis

Existing Impervious = 4.1 acres

Proposed Impervious = 3.65 acres

- **BSE Change in Impervious** = Purposed - Existing = $3.65 - 4.1 = -0.45$ acres
- **Net decrease in impervious**, *does not* have to meet new development requirements.
- Total existing impervious being treated by sand filter (now removed) = 1.2 ac.
- Total existing impervious being treated by Gudelsky = $(0.5 * (3.65 \text{ ac} - 1.2 \text{ ac})) = 1.23$ acres
- **Treated impervious prior to redevelopment** = $1.2 + 1.23 = 2.43$ ac.
- **Existing untreated impervious** = $3.65 - 2.43 = 1.22$ ac.
- Impervious requiring treatment =
50% untreated impervious + replacement of 1.2 acres treatment lost by removing sand filter =
 $0.5 * (1.22) + 1.2 = 1.81$ acres
